Unbridled Development of Urban Space and its Implications for the Preservation of Landmarks

The Morro da Queimada Archaeological Site, Ouro Preto, Brazil

Marco Fonseca, Frederico Sobreira, M. Estela Rainho and Marcus Oliveira*

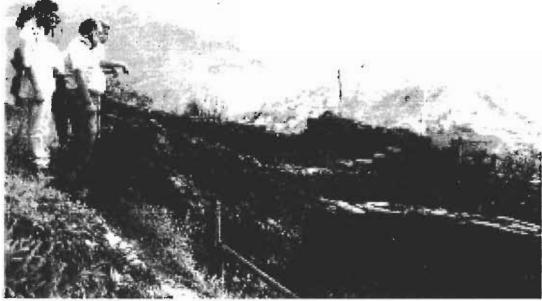
Figure 2 Aspects of the ruins of the Morro da Queimada site. The ruins are mainly composed of "canga", a lithified surficial rock formed of detrital fragments cemented by goethite. One may find ruins of houses, walls, *mundeos*, channels and other mining equipment

A concentration of ruins still exists in the upper part of the Morro da Queimada site. The cartography of those ruins has revealed vestiges of houses, walls and mining equipment (Figs. 2 and 3). The ruins are north of 15th August Street (Fig. 4), covering an area of about 250,000 m². The area is limited to the north by the top of the Ouro Preto range and to east and west by scarps that were created from the mining excavations. The only place where a similar set of ruins can be found is at the Passagem de Mariana village. Dwellers tell about the removal of blocks of canga, a ferruginous lithified surficial rock, from the ruins to be used in the building of new houses during the 1960s and 70s. This process can still be seen in the use of ruins as bases for new houses or parts of ruins in new buildings (Figs. 3a and b).

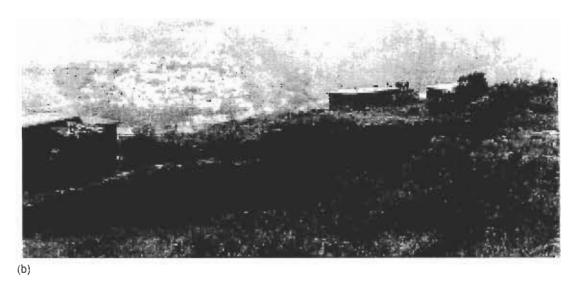
Figure 3 Photographs of recent use of the Morro da Queimada site. Recent land-use is achieved by the removal of ruin fragments for new buildings and also by new buildings in the middle of the site

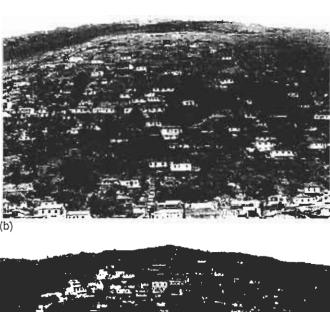
Figure 6 The visual effect of encroaching process. By comparing photographs from 1990 (photo A) and 1998 (photo B), it is possible to measure the speed of unplanned land-use. Take the highest point on both photographs for reference. At the top of both photos is the remnant set of ruins
